LONG RANGE ACOUSTIC PROPAGATION PROJECT.  
BLAKE TEST SYNOPSIS REPORT

**Long Range Acoustic Propagation Project**

**BLAKE TEST Synopsis Report**

**TECHNICAL REPORT**

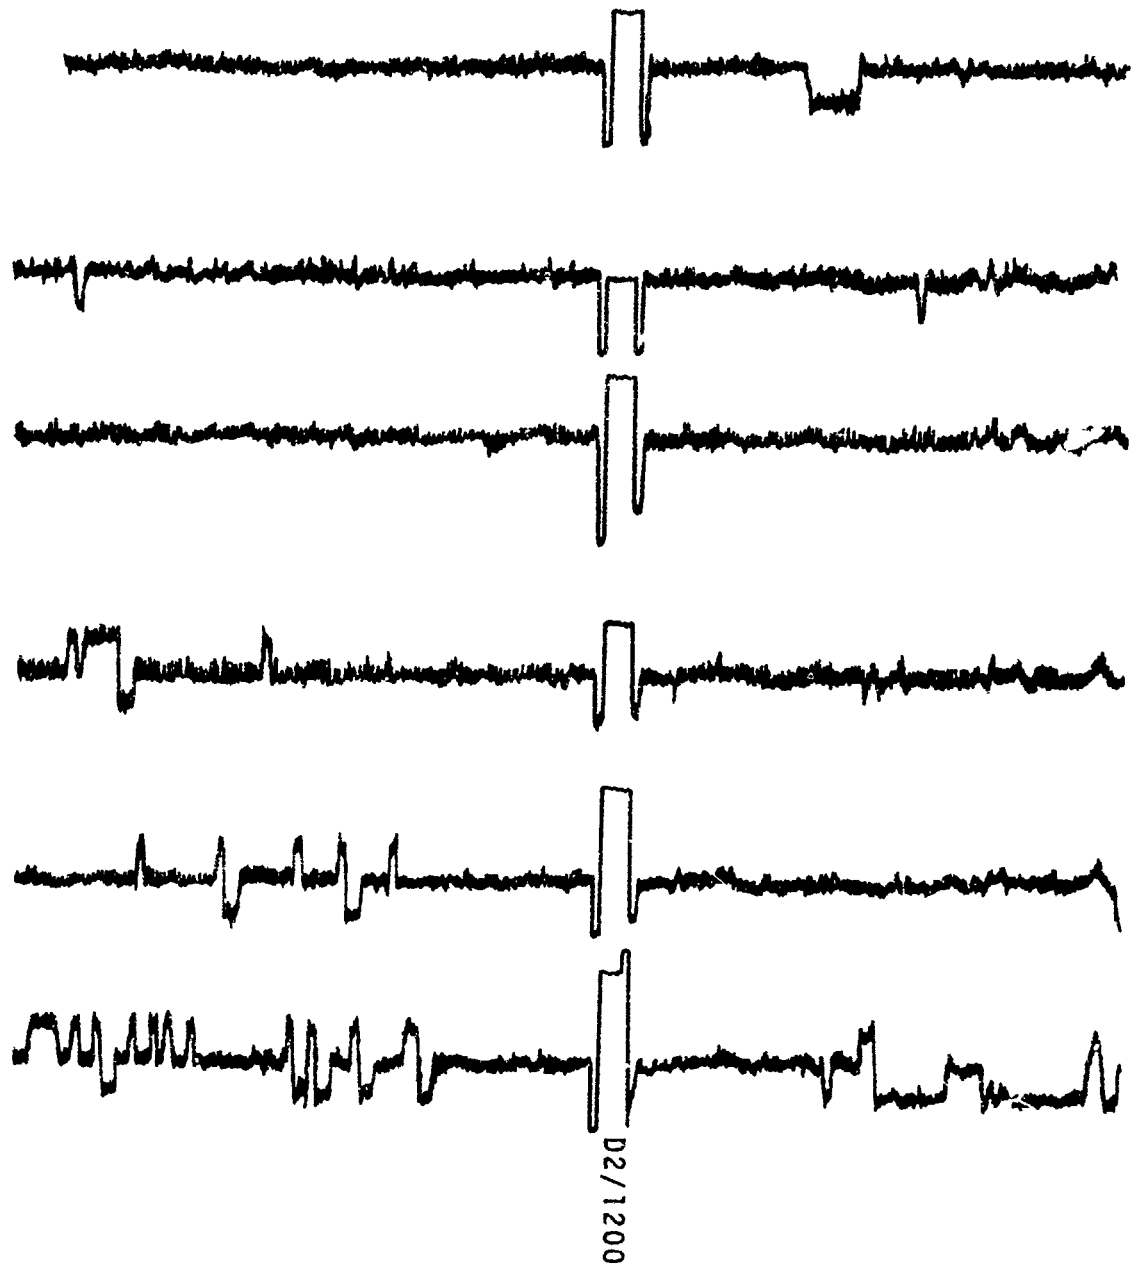
After the first calibration sequence a problem developed in the calibration system of hydrophone number six of the WHOI/TI mooring. There seemed to be a loss of synchronization between the level of the calibration signal and the gain state of the amplifier system. This was evidenced by a "finger" appearing in the last quarter of the calibration signature, see Figure 6. This "finger" protruded above the level of the calibration signal which is designed to be level throughout.

Figure 6. Broadband Time Record Calibration Error

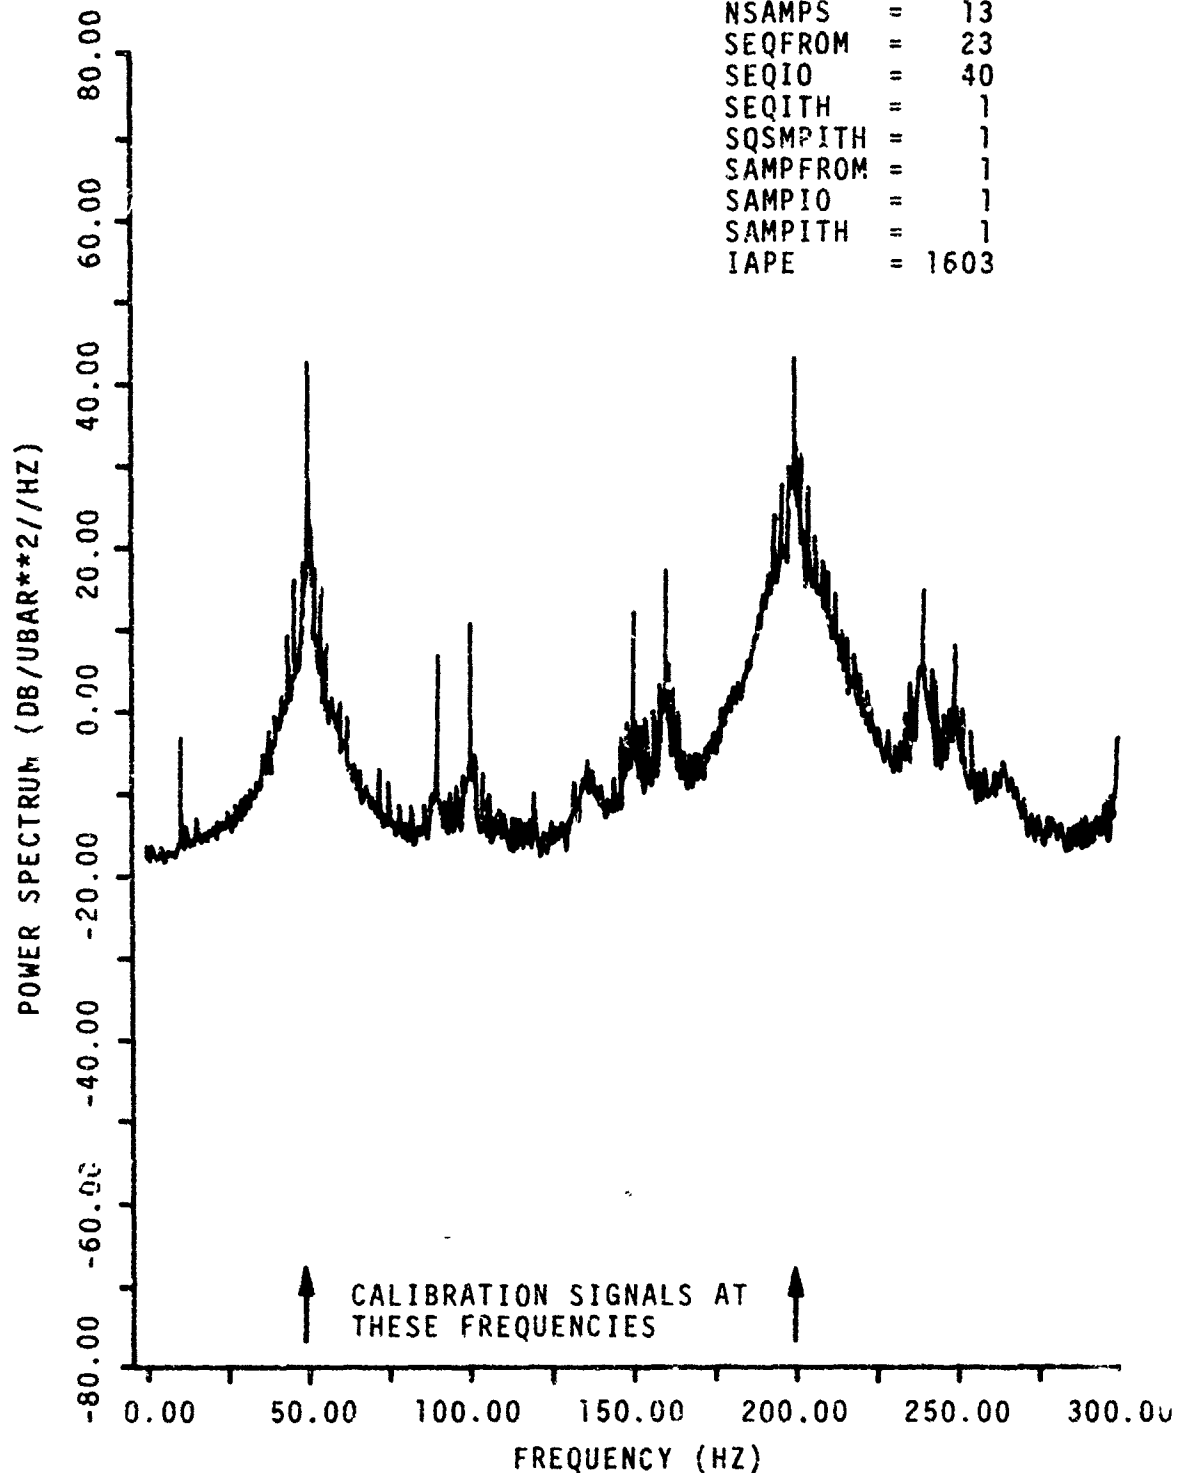
Evidence exists of a non-linearity somewhere in the data recording or playback systems. This is manifest in plots of the spectra of calibration signals; Figures 7 and 8, which show not only the 50 Hz and 200 Hz lines, but also the harmonics of 50 Hz (which unfortunately for analytical purposes are also located at difference frequencies). LOFARgrams also always show harmonics of lines; see for example Figure 9. Some harmonic distortion is inevitable and acceptable. As long as the energy in the harmonic stays well below that of the signal, e.g., 30 dB, there is no problem; see Figure 7.

Figure 7. Calibration Sequence Power Spectrum,  
 BLAKE TEST

There exist data processing non-linearities in the ACODAC system. These should be investigated quantitatively as to their effect and removed if necessary.

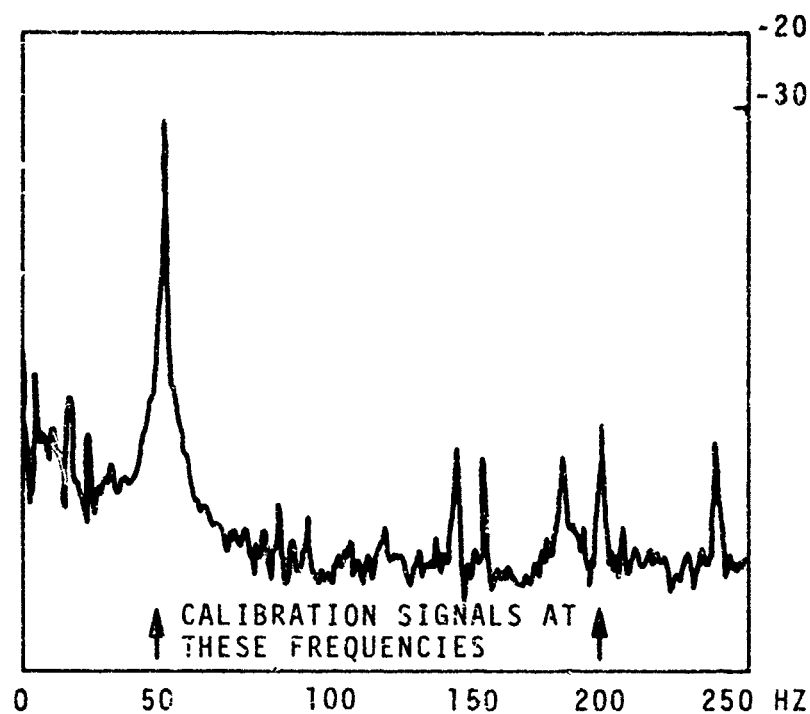
Figure 8. Calibration Sequence Power Spectrum  
BLAKE TEST, RPM 004, 0000Z 13 June

But when the energy in the harmonics approaches that of the signal, Figure 8, an unacceptable data processing situation results.

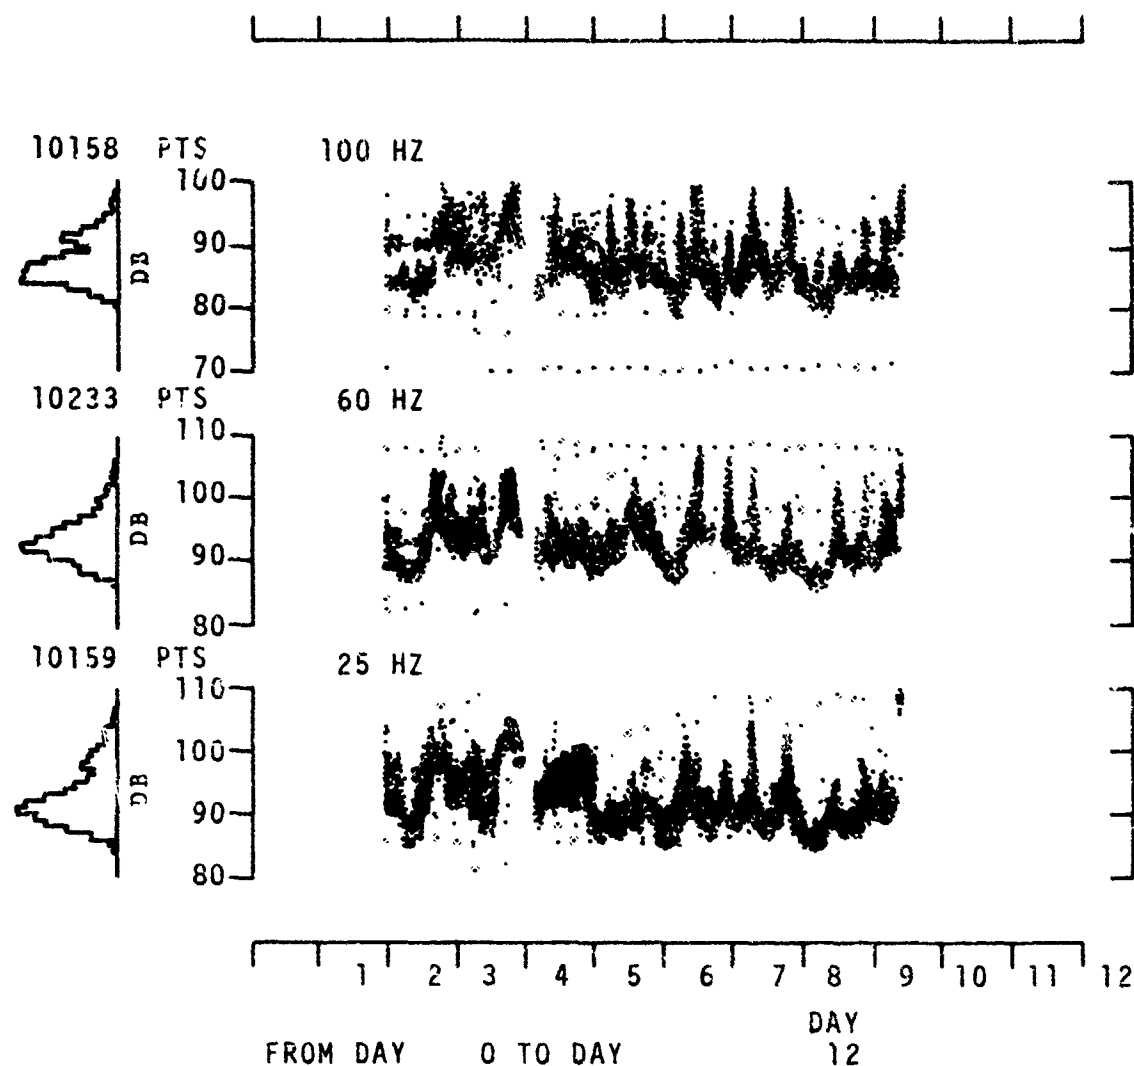
Strumming occurred frequently in the hardware WHOI/TI array. At times this strumming prevented the recovery of acoustic

Figure 10. 1/3 Octave Time Series Data BLAKE TEST WHOI/TI  
Array Hydrophone No. 6

- a. De-sensitizing the ITC 8020 hydrophones by moving the mechanical as well as electrical 3 dB down points to approximately 8 Hz.
- b. Roll off the KPM data amplifiers at the low frequency end of the spectrum with the 3 dB down point at approximately 8 Hz.
- c. Investigate the feasibility and cost of installing mechanical strumming spoilers on the cable in the vicinity of the hydrophones.

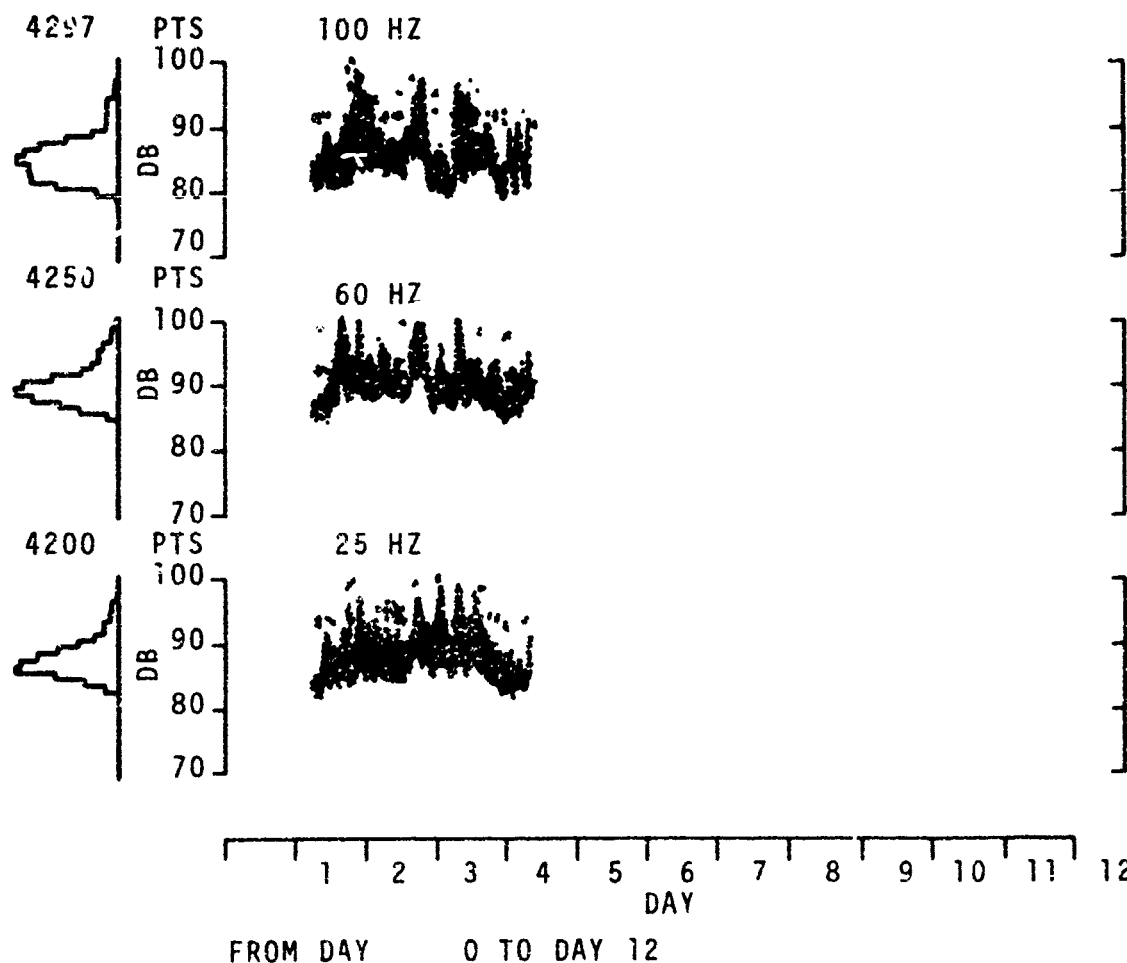
The location of the most noticeable strumming as seen in LOFAR records would migrate from one hydrophone to another in the Woods Hole/TI mooring. In the University of Miami mooring, no noticeable strumming was evident. In view of the absence of a mooring above the sixth hydrophone, this was not a surprising observation.

Figure 11. 1/3 Octave Time Series Data. BLAKE TEST UM Compliant Array, Hydrophone No. 6
